Uncertainty analysis of the Gloria storm in catchment la Tordera

WATEREUROPE
Hydroinformatics for water resources and water related hazards management in Europe

Gloria event in la Tordera – Uncertainty analysis in the catchment

Gonzalo Olivares & Ernest Bladé
Universitat Politècnica de Catalunya - Spain
gonzalo.olivares@upc.edu

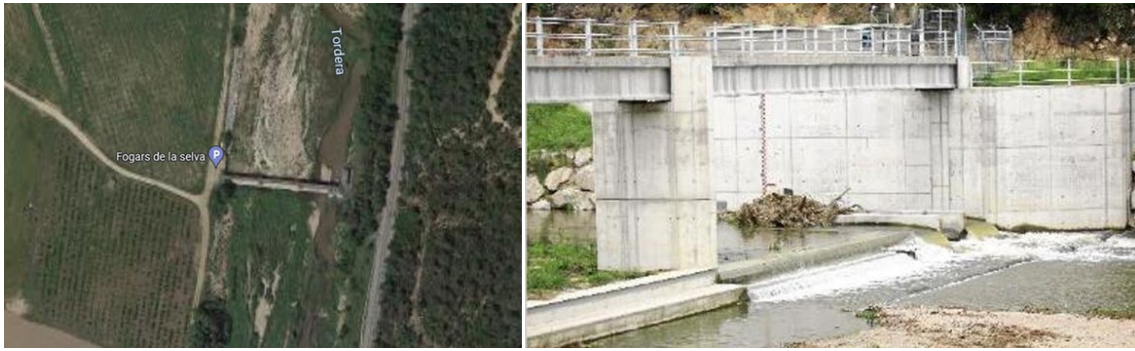
Figure 6. Flow gage Can Simó in Catchment la Tordera.

For the register of the discharge a flow gage (*Can Simó*) is located in the medium-last part of the catchment. This station registers more than 80% of the surface of the catchment and yield information of hourly and daily discharge (Figure 6).

The station is built in concrete and located in a section that allows to evaluate the response of the catchment properly before rain events. At the same time allows to understand the behavior of the water balance in the long run.

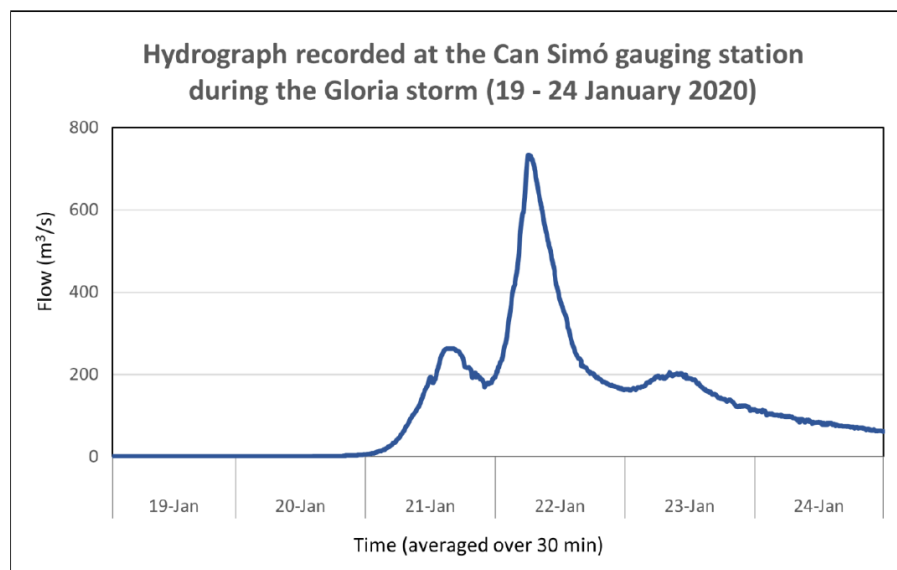
During the event, the station recorded the hydrograph generated by the basin. This discharge curve was the one that probably caused the damages observed in the last part of the river (delta). The figure 7 shows the discharge curve.

Figure 7. Observed hydrograph obtained from the Can Simó gage station.

A first face was carried out in order to study the hydrograph of figure 7. For that, a hydrological model was built using HEC-HMS using all the information available.

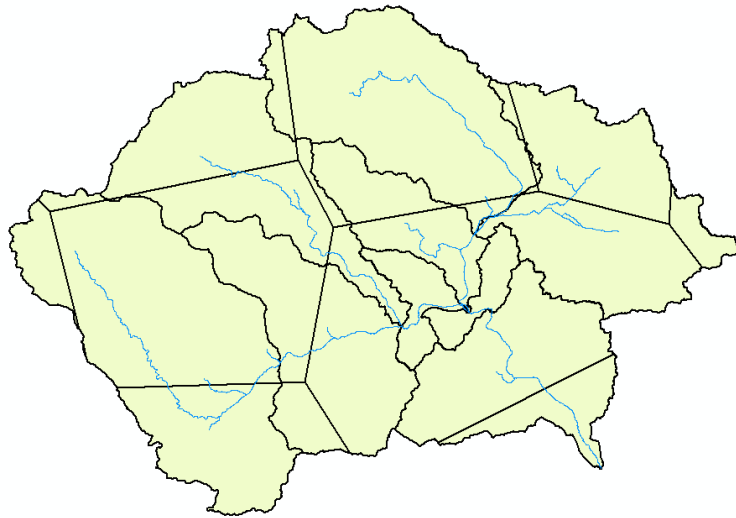
using the Thiessen method. This implied that each raingage station had an area of influence in the basin, describing a partial spatial distribution of the rainfall.

Figure 10. Thiessen polygons defined in the basin.

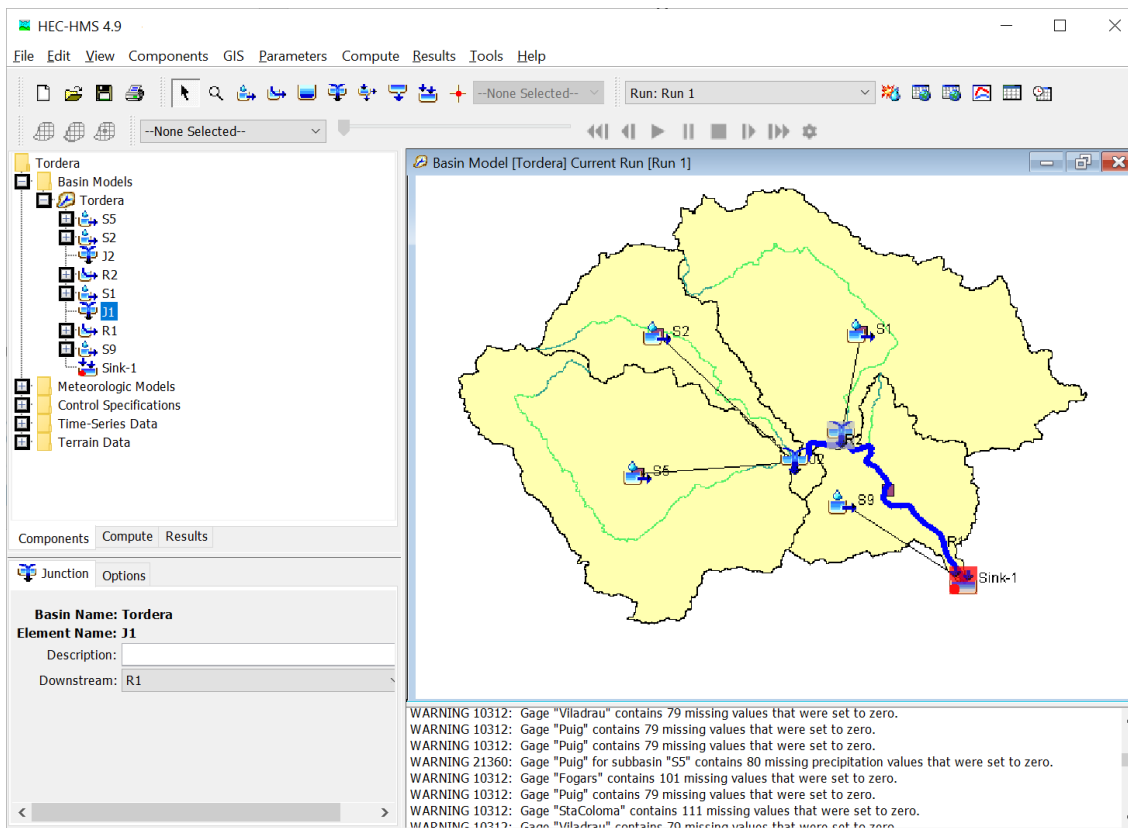
- Loss: Curve Number.
- Transform: SCS Unit Hydrograph
- Propagation: Muskingum.

- Base Flow: recession method.

Figure 11. Semi-distributed model for la Tordera built with HEC-HMS.

The figure 11 show the model built in HEC-HMS.

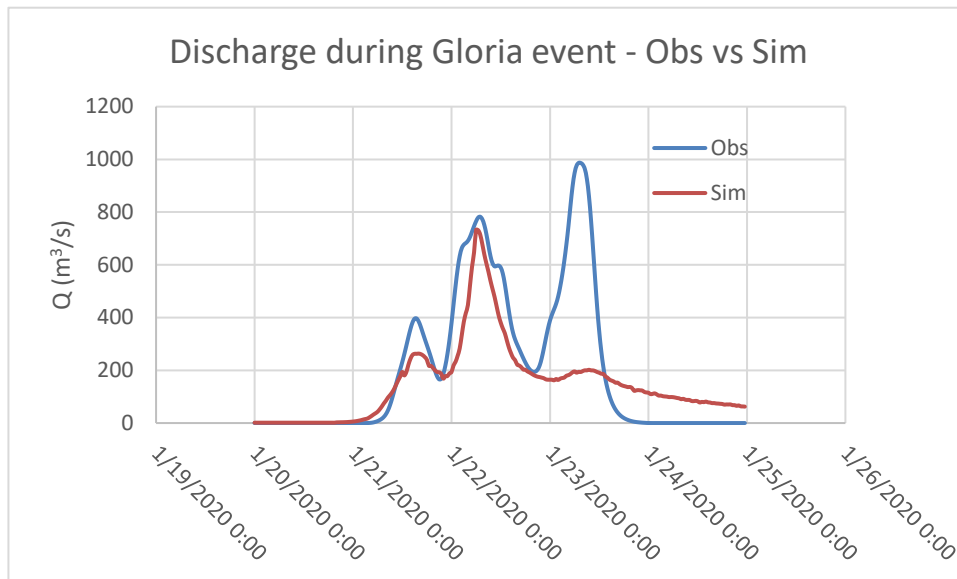
The results of the models were used to understand and to assess the capacity of the hydrological model to simulate the actual event. From the results it was observed that the model was not totally able to describe the hydrological response of the basin recorded at Can Simó discharge gage station. If the model is not able to perform as expected, many may be causes of this situation. One of these reasons is that is not possible to have the whole knowledge of the system, therefore the tool used and the information used is subjected to uncertainty. Analyzing this uncertainty and evaluating the main sources of it, helps to improve the models and to explain the results and the inconsistencies obtained from the simulation. As an example, the figure 12 the results obtained for the simulation of the discharge carried out by the hydrological model, compared with the observed that.

Figure 12. Observed and simulated discharge obtained with HEC-HMS.

The propagation of the hydrographs in the delta of the Tordera river, presented in the figure 12 (observed and simulated), will yield different flood maps, because the shape and volume of the hydrographs are different. If hydrological models are used to be trusted, this sort of issues need to be addressed so the uncertainty that causes it.
